## ROLLOVER CRASH ANALYSIS OF A ROAD TANKER WITH SELF-STEER AXLES

In March of 2006 a rollover crash occurred in New Zealand involving a cryogenic road tanker comprising a twinsteer prime mover towing a quad-axle semi-trailer with two self-steer axles in the rearmost positions of the quad-axle set. The crash occurred on a long sweeping bend and involved a clean separation between the prime mover and the semi-trailer at the turntable connection. There were no injuries in the incident only damage to the tanker semi-trailer and local property. To determine the cause of the rollover a detailed survey of the crash site was made accompanied by an extensive investigation using state-of-art numerical modelling of vehicle dynamics. The numerical modelling showed the baseline vehicle to have poor high-speed off-tracking performance, which was found to be very sensitive to speed. These two factors, in combination with overloading (if it occurred) and speed management, appeared to be the main contributing factors that led to the rollover crash. A review of self-steer axle policy has been carried out by the regulating authorities in New Zealand.

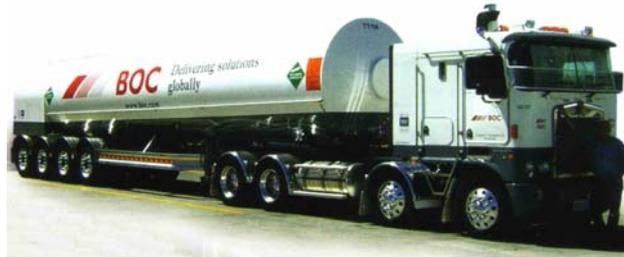
**Figure 1** – Example CO<sub>2</sub> road tanker  
(semi-trailer self-steer axles are in positions 3-4, the two rearmost axles).

In March of 2006 a rollover crash occurred in New Zealand involving a road tanker comprising a twinsteer prime mover towing a quad-axle semi-trailer. The crash occurred on a long sweeping bend and involved a clean separation between the prime mover and the semi-trailer at the turntable connection, with subsequent rollover of the quad-axle semi-trailer unit in a nearby rural pasture where it came to rest. There were no injuries in the incident only damage to the tanker semi-trailer and local property damage. An example CO<sub>2</sub> road tanker, identical to the one involved in the rollover incident, is shown in Figure 1.

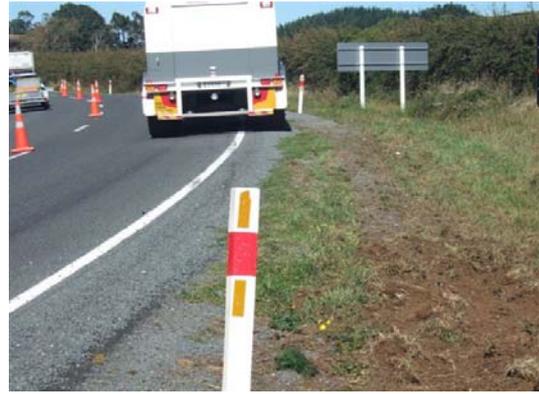
**Figure 2** – Location of bend on which the rollover occurred (left image, from <http://www.multimap.com>), and traffic lane and edge detail (typical).

Given the above, it is important to note that the traffic lane and shoulder width details shown in **Figure 2** for this particular road suggests that offtracking of 0.8 m could be safely accommodated only if the road tanker is located either in the centre of the lane, with no margin for error, or, preferably, nearer to the centreline, giving the driver a small margin for error. However, in the presence of oncoming traffic, either scenario would present the driver with a greater workload and increase the likelihood of running wide of the lane centre.

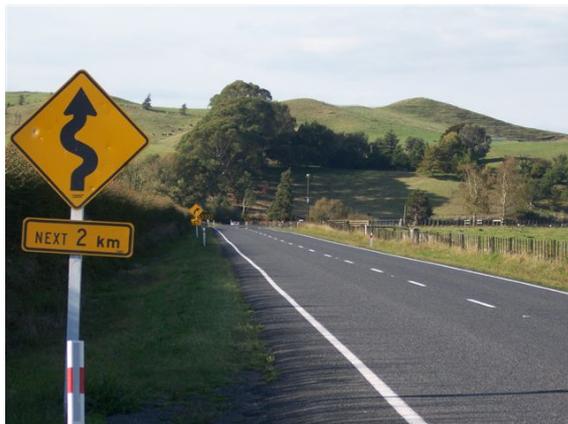
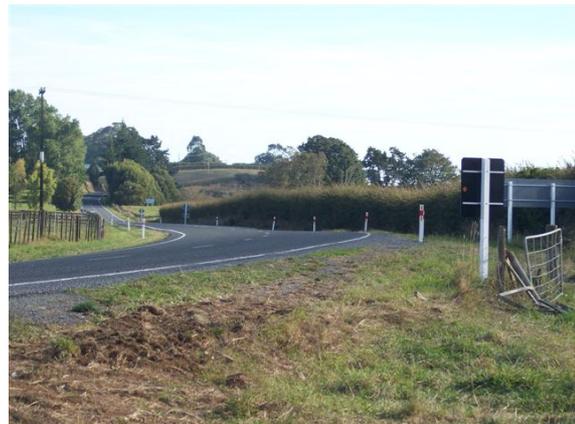
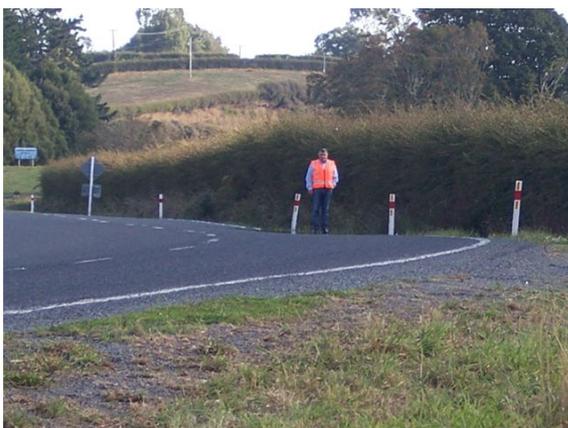
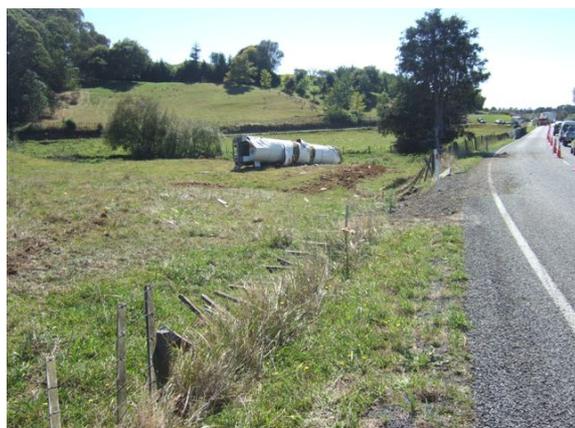
Photographs taken by BOC Ltd at the site of the rollover are reproduced below in **Figure 3**. These show the following points of note: northbound approach to the bend and the 75 km/h advisory speed sign (top-left image); a view in the southbound direction partway through the bend (top-right image); a dip in the road surface at the start of bend (lower-left image); and, the straight approach on the exit side of the bend together with the final resting position of the rolled tanker semi-trailer and adjoining property damage (lower right image).

**Figure 3** – Photographs taken by BOC Ltd at the site of the rollover

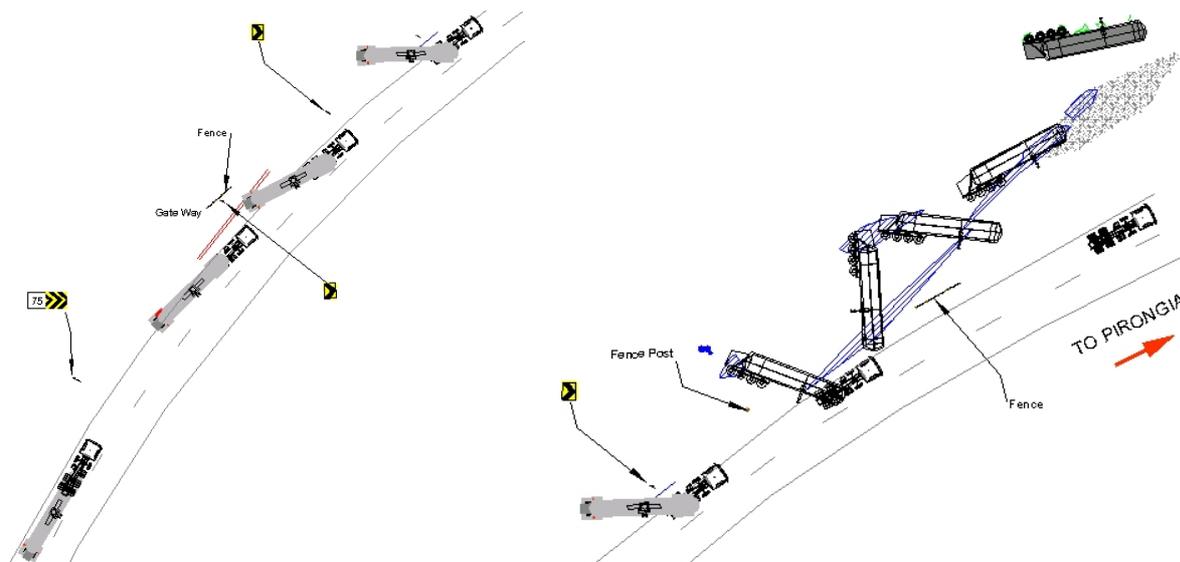
- a) Upon entering the bend the tanker semi-trailer experiences excessive and increasing levels of high-speed offtracking;
- b) As the high-speed offtracking continues to increase the tyres on the quad-axle group, which are now operating at a large slip angle that continues to increase, move out of the traffic lane (sealed pavement) onto the verge and batter which falls away rapidly (initial part of right-side image in **Figure 4**);

- c) The tyres on the quad-axle group now sliding sideways along the batter on uneven soft terrain catch and trip the tanker semi-trailer. The large articulation angle that has developed, and the resulting large forces and moments acting on the turntable as the semi-trailer rapidly slows, causes the turntable to fail, tearing it from its mounts commencing at the rear right corner;

- d) A clean separation occurs between the semi-trailer and the prime mover;
- e) The tanker semi-trailer continues to tumble and roll until it comes to rest while the prime mover now free of the semi-trailer continues unimpeded along its path.

**Figure 4** – Initial and final stages of the rollover sequence, left and right images respectively, as recorded by the crash survey.

The main results from the simulation of the rollover incident are presented in **Figure 10**, which shows the maximum value of high-speed offtracking for a range of speeds. It is important to note that the maximum value of high-speed offtracking normally occurs early, for example, when the rear end of the vehicle is about three vehicle lengths into the bend, consistent with **Figure 4**.

For the baseline vehicle the above paints a picture that is consistent with the scenario presented in **Figure 4**, and shows excessive levels of high-speed offtracking near to the entry point to the curve would be likely to occur. This suggests the main factors that led to the rollover were:

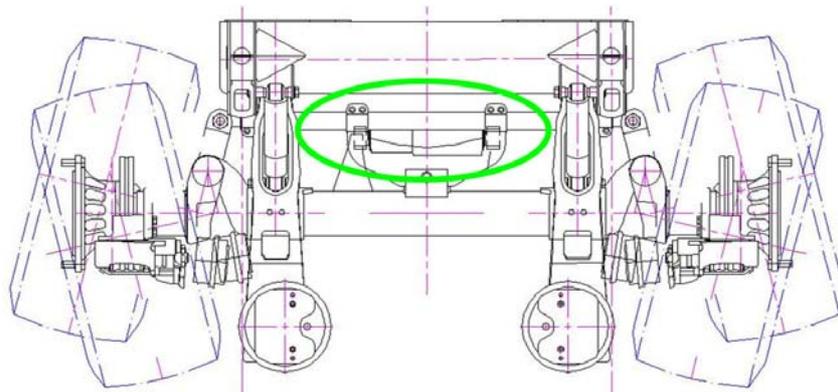
A plan view drawing of the baseline self-steer axle arrangement is shown in **Figure 5**. The basic self-tracking or self-steer function derives from castor action of the wheels resulting from the forward-set steer axis. As shown, to achieve the desired steer geometry the left and right-side wheels are connected by a tie-rod through forward projecting steering arms connected to each stub axle.

**Figure 5** – Baseline self-steer axle showing range of steer movements and centrally located spring arrangement (shown circled) for self-centring.

For the baseline version of the self-steer axle the centralising moment is produced by a pre-tensioned bi-directional spring contained in a “shock absorber” type housing. At one end the spring in its housing is attached to the tie rod and at the other end to the axle. This arrangement produces a centralising moment that is independent of axle and wheel load.

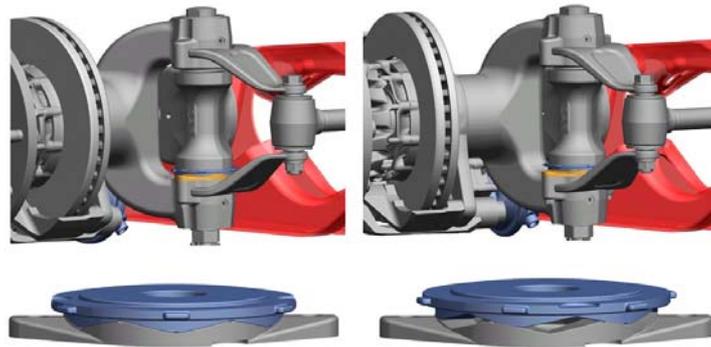
In the later model version of the self-steer axle, the mechanism for providing the centralising moment has been changed. Details of the mechanism for providing the centralising moment are disclosed in **Figure 6** and **Figure 7**.

The two key elements of the later model self-steer axle, the “wave washer” and “metalastic” bush, are shown in the exploded view of the steering knuckle as **Figure 7**. The wave washer produces a centralising moment that is: 1) dependent on the steepness of the angle of the inclined mating surfaces and the friction between them; and, 2) proportional to the vertical force on the steering axis (the wheel load). The centralising moment from the second mechanism is independent of steer angle.

**Figure 6** – Later model self-steer axle shown in the straight-ahead (top-left) and off-centre steered positions (top-right) together with corresponding alignment of the “wave washer”.

In addition, the metalastic bush provides a clamping force across the wave washer inducing an additional centralising moment proportional to the applied preload and the product of the axial stiffness of the metalastic bush times the steer angle. A high preload and stiff metalastic bush produces a proportionally higher centralising moment that increases more rapidly with steer angle. If the clamping force is large enough, and the stiffness of the metalastic bush high, the joint could theoretically become locked and there would be no self-steer freedom.

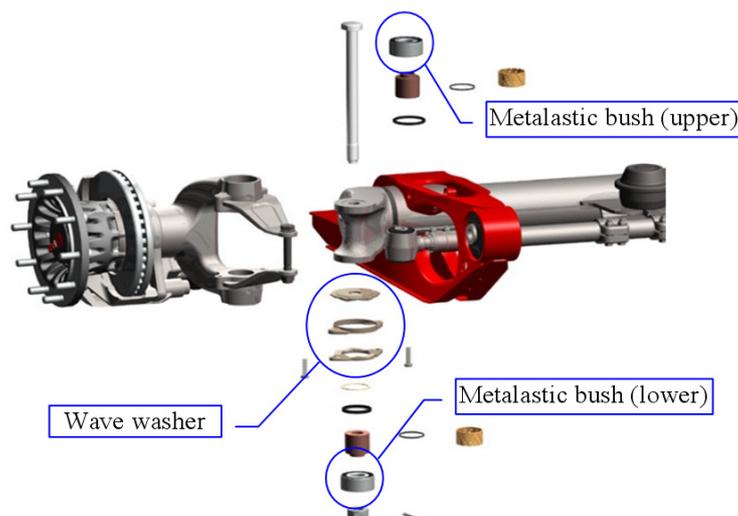
**Figure 7** – Exploded view of the later model self-steer axle steering joint

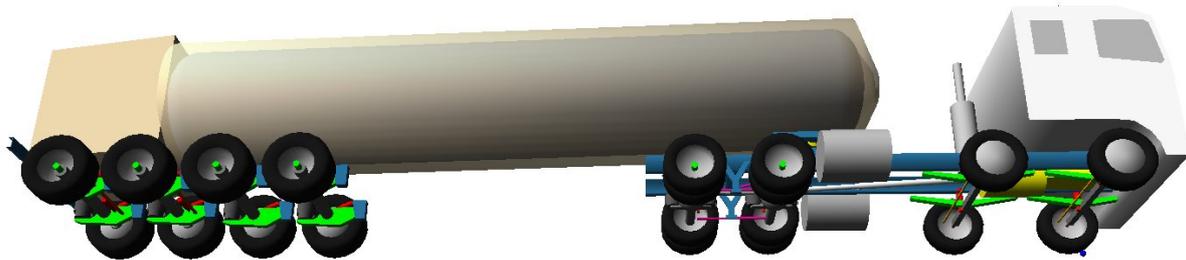
A general view of the numerical model, as well as specific details related to the prime mover and tanker semi-trailer, are shown below in **Figure 8**.

**Figure 8** – General view of the numerical model of the BOC road tanker.

Mechanical properties were assigned to components (sprung and unsprung masses, suspension, tyres, etc) in each of the models consistent with the components installed on the road tanker involved in the rollover incident. Typically, data were obtained from manufacturers and component suppliers. Where vehicle, system or component level information could not be obtained, representative data from a previous major study of the performance of the Australian heavy vehicle fleet (Prem et al, 2002) were used. Where necessary, information was sourced from MSD's extensive heavy vehicle database and library.

Suspensions and tyre elements in each of the models were represented as non-linear systems incorporating state-of-the-art features. Where component level test data were supplied (self-steer axles, tyres, airbags, shock absorbers, for example) the component models were adjusted and tuned to accurately reproduce the measured properties.

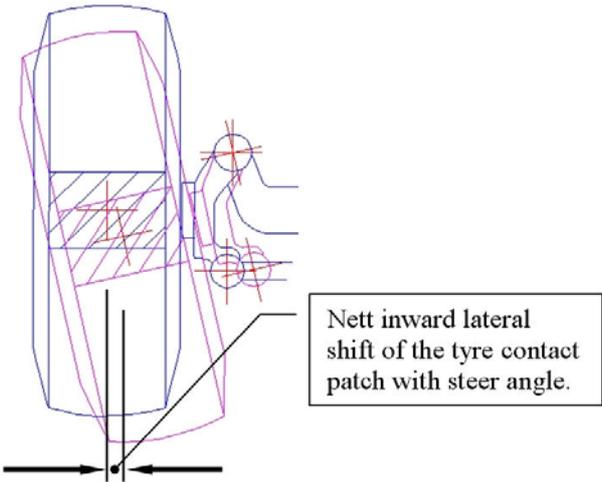
The sensitivity of static rollover threshold to the steer centralising moment and/or maximum steer angle of the self-steer axle can be easily explained by reference to **Figure 9**, which illustrates how the self-steer action leads to a reduction in the effective wheel track width.

**Figure 9** - Illustration of inward migration of the tyre contact patch with steer-angle leading to a nett reduction in effective vehicle track width

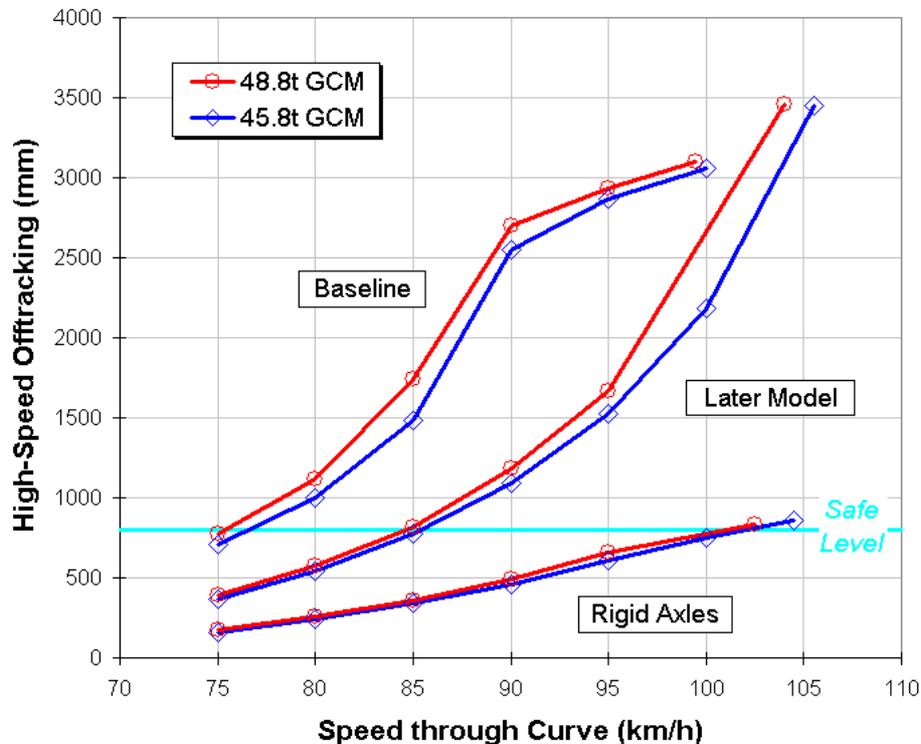
Also shown in **Figure 10** is an assumed high-speed offtracking “Safe Level”, set at a value of 0.8 m. This value is made up of the 0.6 m from the PBS high-speed transient offtracking Level 1 (L1) performance requirement, which is consistent with the performance requirement specified in the former “Steerable Rear Axles Policy” (LTSA, 1996), to which has been added an allowance of 0.2 m corresponding to about half the width of the wide single tyre. A safe

**Figure 10** - Summary of results from rollover incident simulations

With the above assumptions in place, **Figure 10** shows that if the vehicle is travelling at the posted advisory speed of 75 km/h, each of the three variants at each of the two GCMs (45.8 t and 48.8 t) could safely negotiate the bend. However, an increase in speed of just 5 km/h to 80 km/h would cause the Baseline variant to exceed the assumed high-speed offtracking safe level at either of the two GCMs. **Figure 10** shows clearly that any further increases in speed lead to very rapid increases in high-speed offtracking, made marginally worse by increases in the GCM. LTNZ Heavy Vehicle Road Code states that heavy vehicles should reduce speed to 10 km/h below advisory postings, particularly when laden, consistent with BOC Ltd standard procedures.

As clearly shown in **Figure 10**, the Later Model vehicle variant exhibits a marked improvement in high-speed offtracking performance, exceeding the safe level offtracking only at a speed of about 85 and 86 km/h at the higher and lower of the two GCMs considered, respectively. A further more substantial improvement in high-speed offtracking is exhibited by the Rigid Axles variant, further raising the safe-level speed to just above 100 km/h at either of the two GCMs. Also, the high-speed offtracking for the Rigid Axles variant does not exceed a value greater than about 870 mm even at a speed that causes the vehicle to rollover.
