HIGHWAY BRIDGES DYNAMIC PARAMETERS MONITORING

Ján Benèat

During the years 1991-1997 La Franconi bridge over the Danube has been investigated by 24 hours monitoring tests in the summer and the winter time [8,9]. A theoretical prediction of the bridge behaviour and preliminary dynamic loading tests are reported in [10].

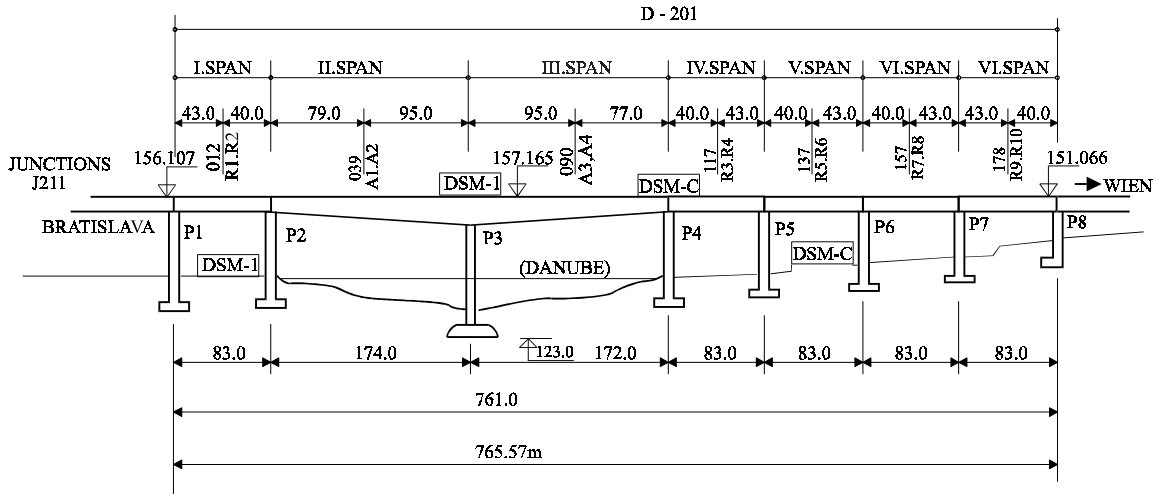
Fig. 2. Longitudinal Section of the Bridge

DSM - 1,2,3, - DEPARTMENT OF STRUCTURAL MECHANICS MEASURING STATION
 DSM - C - DEPARTMENT OF STRUCTURAL MECHANICS MEASURING HEADQUARTER
 A1...A6 - ACCELEROMETERS POSITION

The main bridge structure is composed of seven span continuous beams with one frame pier (P3). Other supports are formed by seven massive piers. The total length of the bridge is 761.0 m with spans 83.0m + 174.0m + 172.0m + 4x83.0m. The highway bridge consists of two independent bridges (left and right bridge) with three traffic lanes each (e.g. three in each bridge for one direction only) and sidewalks on both sides. The bridge box cross-section is

shown in [Fig.1](#) and the longitudinal section in [Fig.2](#)[10].The bridge multispan junction is fully described in [10]

The test programme included field measurements using the instrumentation described in [10] so as to ensure coverage of entire possible range of vibration. The vibration amplitudes were investigated and recorded in selected points of the second and the third span, see Fig. 1,2. The time history of vertical vibration has been registered by accelerometers (Brüel-Kjaer, BK-8306) at points A1,A2,A5,A6.

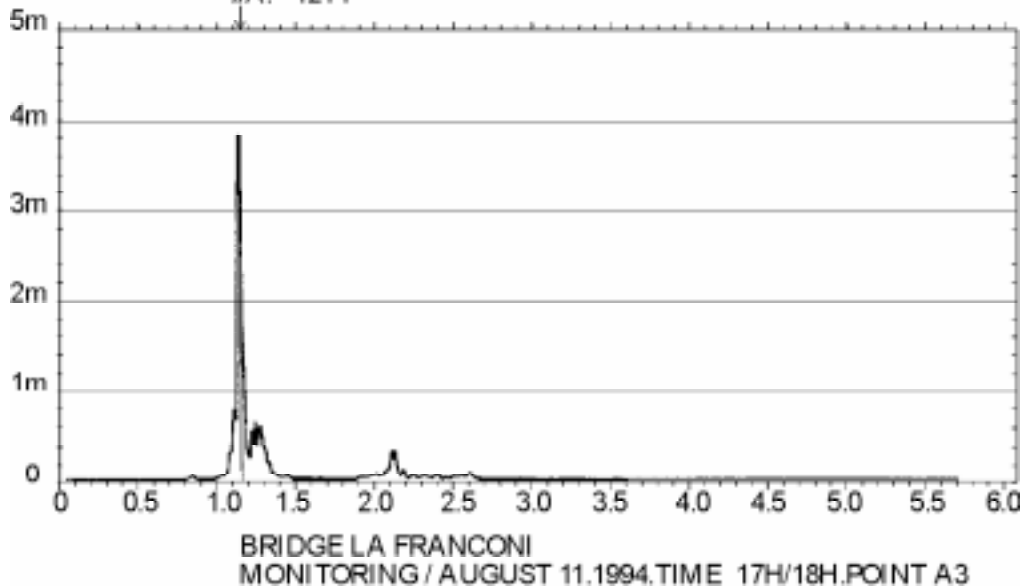
Fig. 3. Power Spectral Densities of the bridge Vibration Displacement Amplitude at Point A3

W 13 AUTO SPEC CH.B [] STORED MAIN Y: 3.90mU²/Hz
Y: 5.00mU²/Hz PSD LIN X: 1.171 Hz
X: 0.000Hz + 6.25 Hz LIN
#A: 1214

The experimental analysis has been carried out in the laboratory of the Department of Structural Mechanics U.T.C. •ilina. The records obtained in the bridge monitoring tests were investigated by using frequency analyser BK 2034 and mentioned PC facilities. [Fig. 3](#) shows power spectral densities (PSD) as an example of the spectral analysis of the monitoring test performed in August, 1994. The damping parameter (D-critical damping coefficient) was found by means of the 3dB bandwidth method and curve fitting techniques. The amplitude analysis has been used to obtain RMS amplitude value of the bridge vibrations during the monitoring tests.
